Pre-Purchase Structural Plus Building Inspection Report

95 Sample Street, Sample Town, 6000

Inspection prepared for: John Sample Date of Inspection: 5/5/2010 Time: 10am Age of Home: Approx. 15 years Weather: Fine, approx 25 degrees

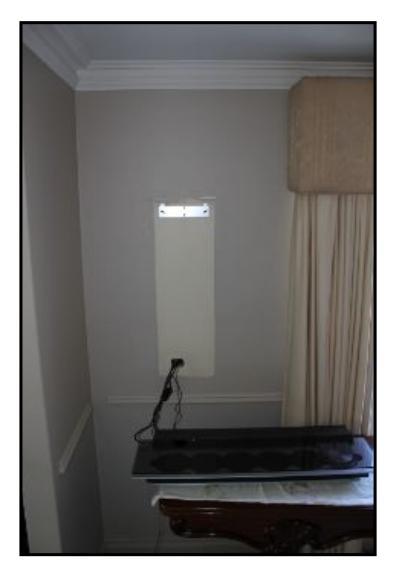
Dining room wall patch needs painting

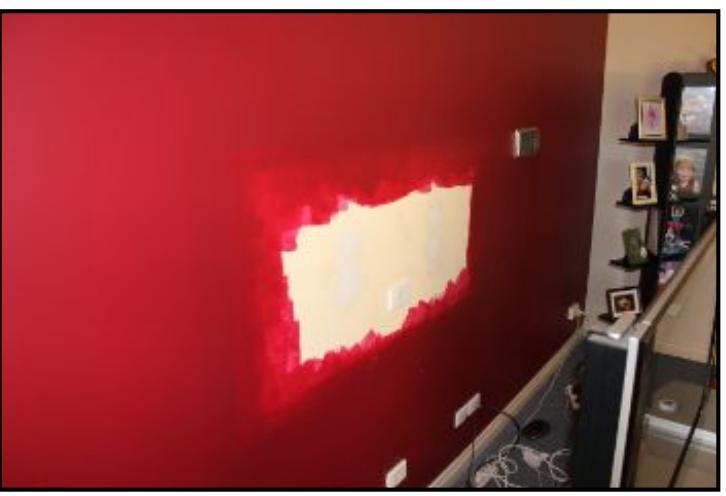
Media room patch in wall needs painting

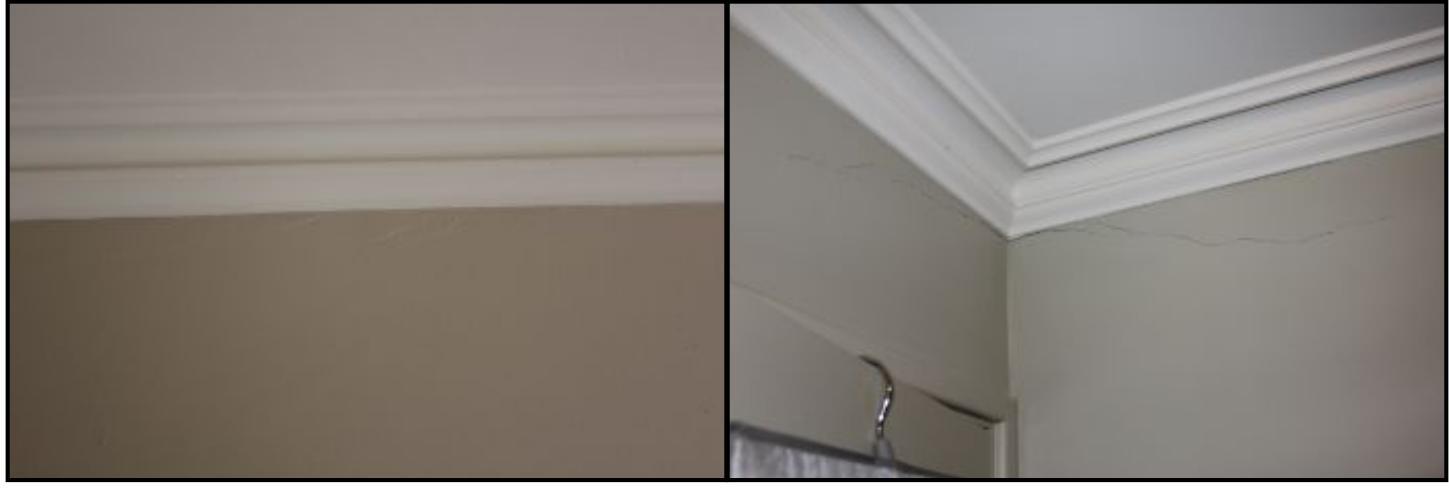
• Settlement cracking in the wall finish noted. This is minor maintenance work and is probably caused by settlement of the structure over time.

Typical settlement cracks noted throughout. Not structural

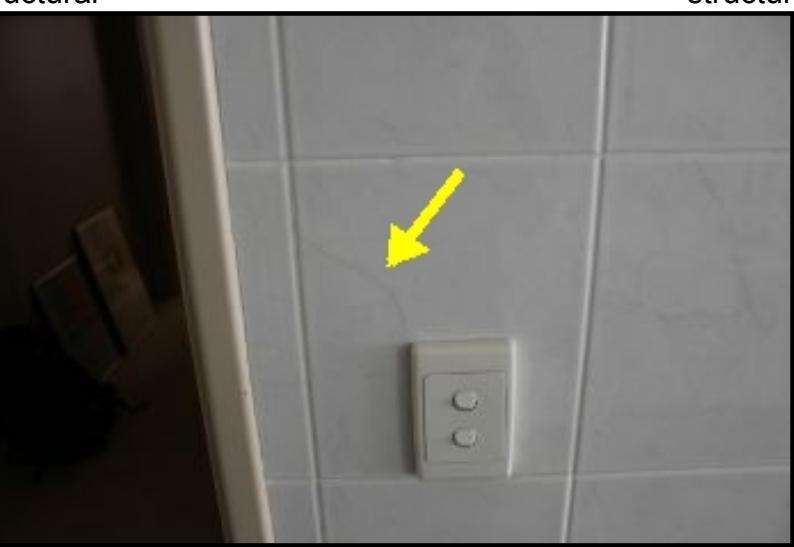
Cracked tile to bathroom wall

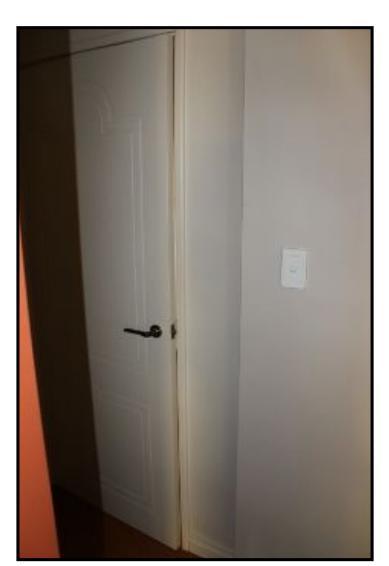
Hallway door is binding and is hard to shut

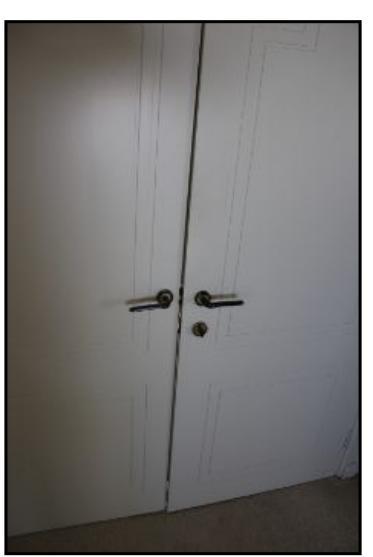
Double door to main bedroom are binding together and can not be closed

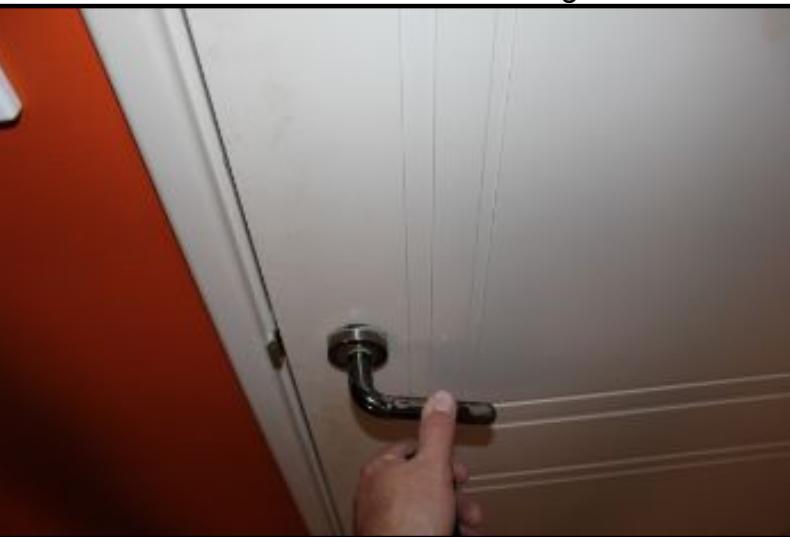
Door handle to bedroom is loose

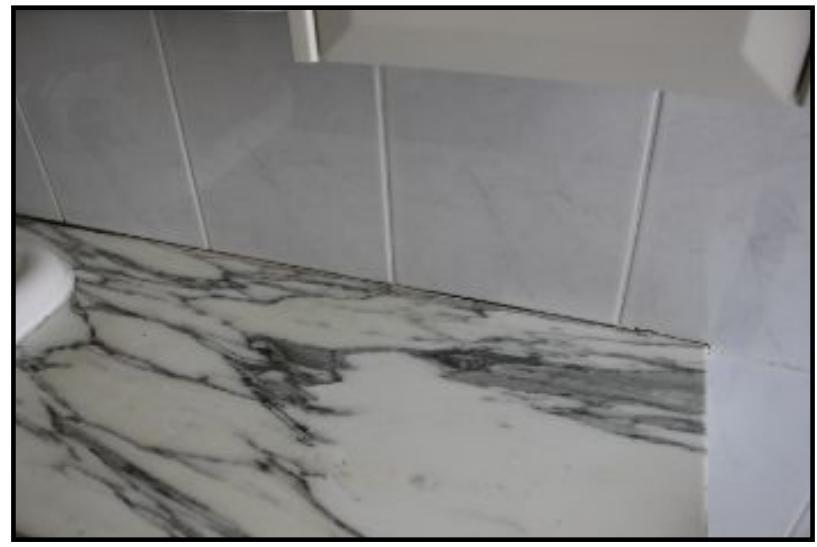
• There is normal wear noted for the age of the bench tops. • Granite bench top appears to not have been caulked when installed. Recommend sealing with silicone along entire length of bench. This prevents water leaks from spills damaging the cabinets.

Bench top needs re-caulking between bench top and tile.

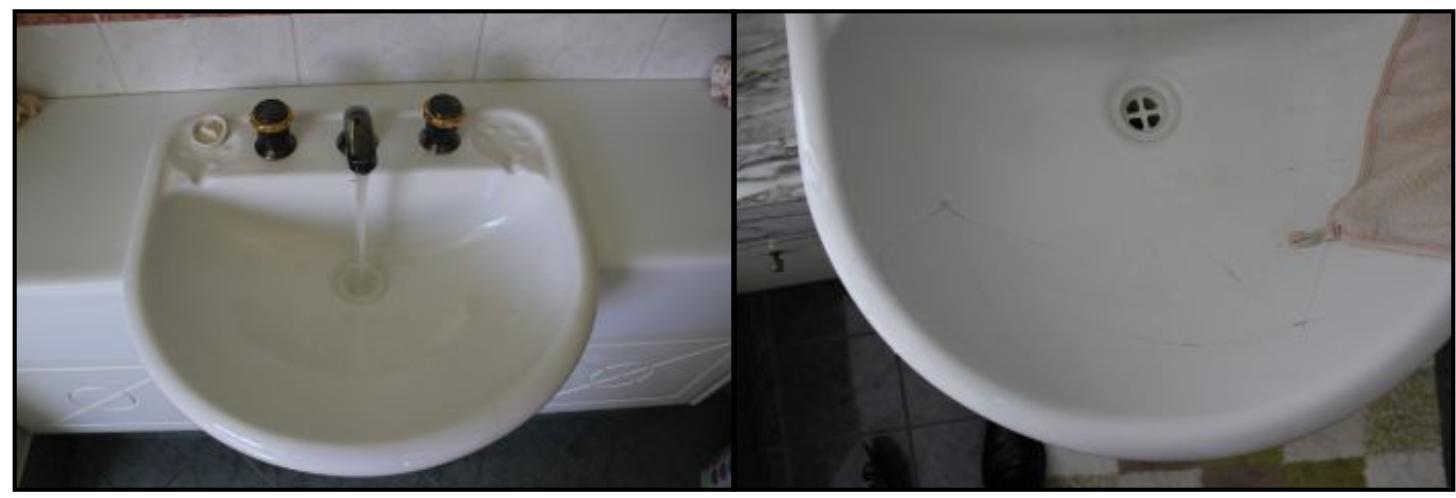
- Ceramic vanity basin noted.
 Hot & cold water taps and spout noted.
 Appeared functional at time of inspection.
 MAINTENANCE: Ensuite vanity basin is cracked and should be replaced.

Ceramic vanity basin is cracked.

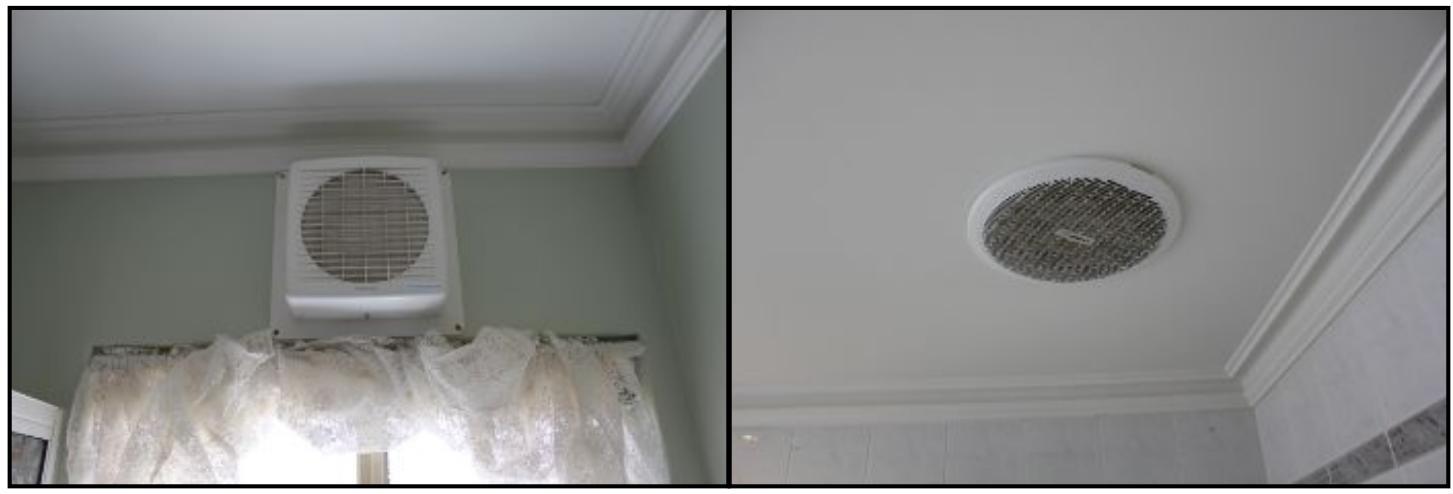
The bath fan was operated and no issues were found.
Ensuite fan grill was blocked with dust and needs to be cleaned to maintain efficiency.

Fan grill is blocked and needs cleaning

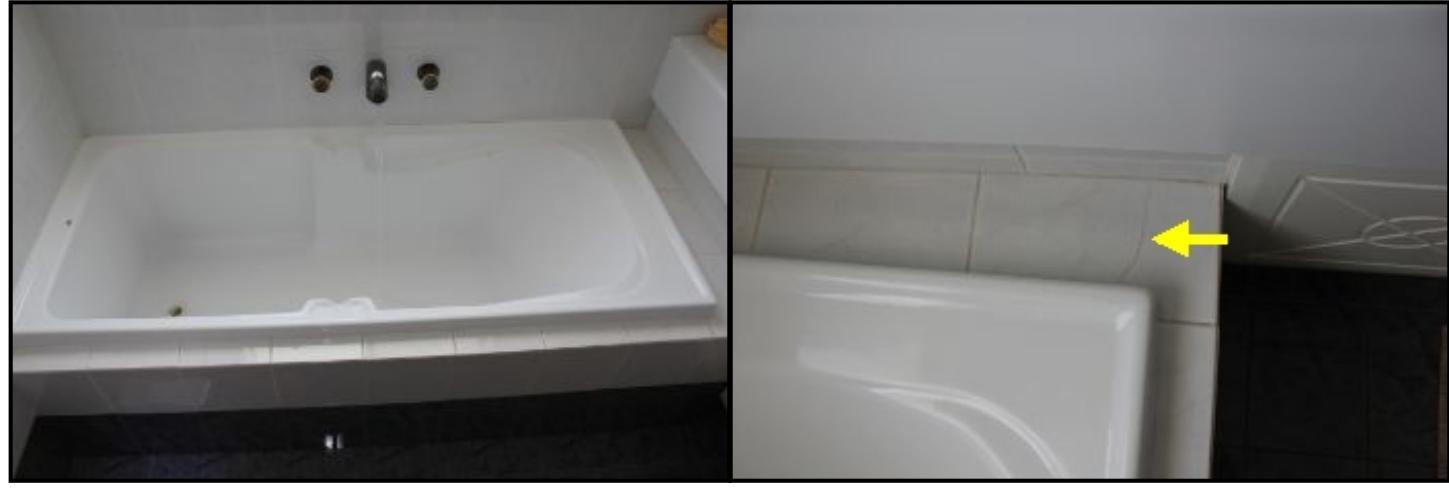
- Observations:
- Plastic bath tub noted.
 Hot & cold water taps and a spout noted.
 Appears functional
 Cracked tile noted of bath hob.

Crack tile on bath hob

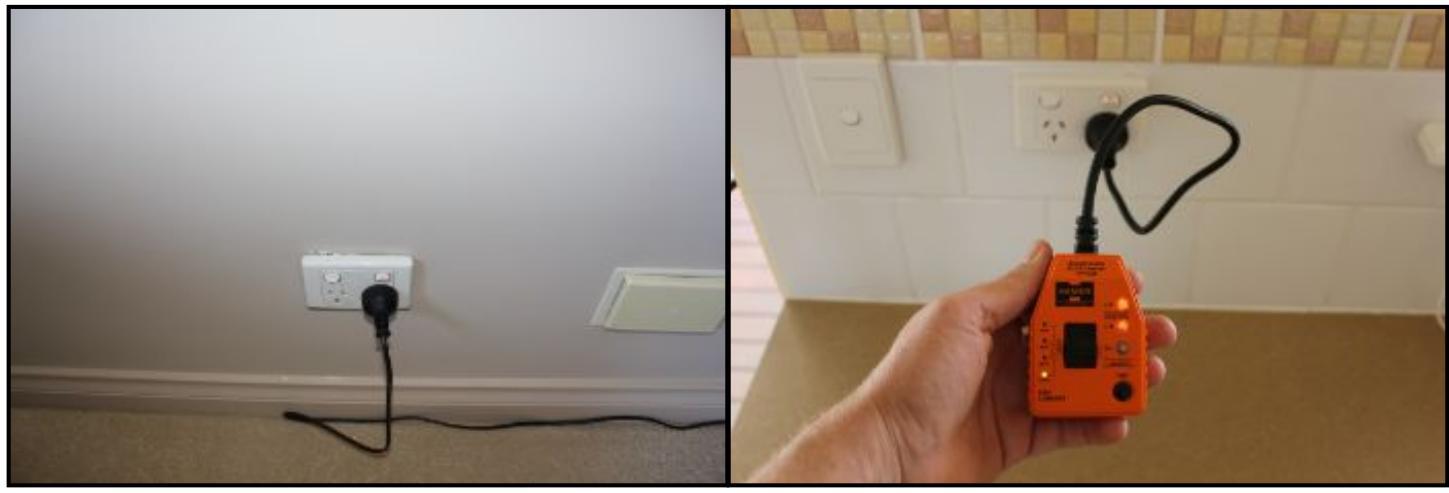
Power point is loose and off the wall.

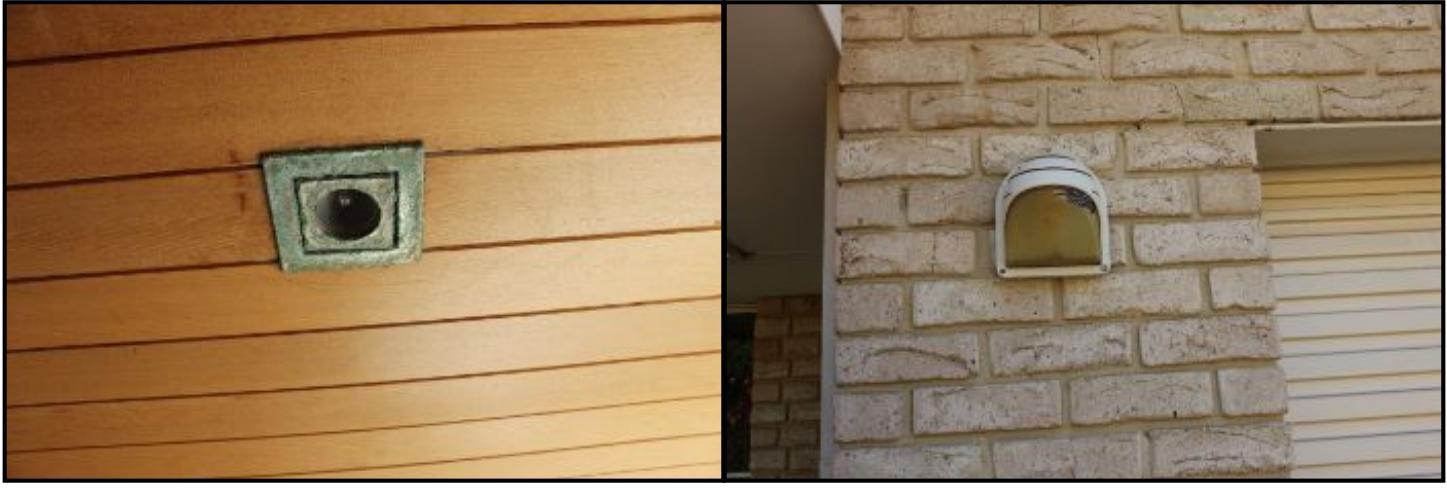
Deck downlight is corroded and needs replacement

Rear garage light glass broken

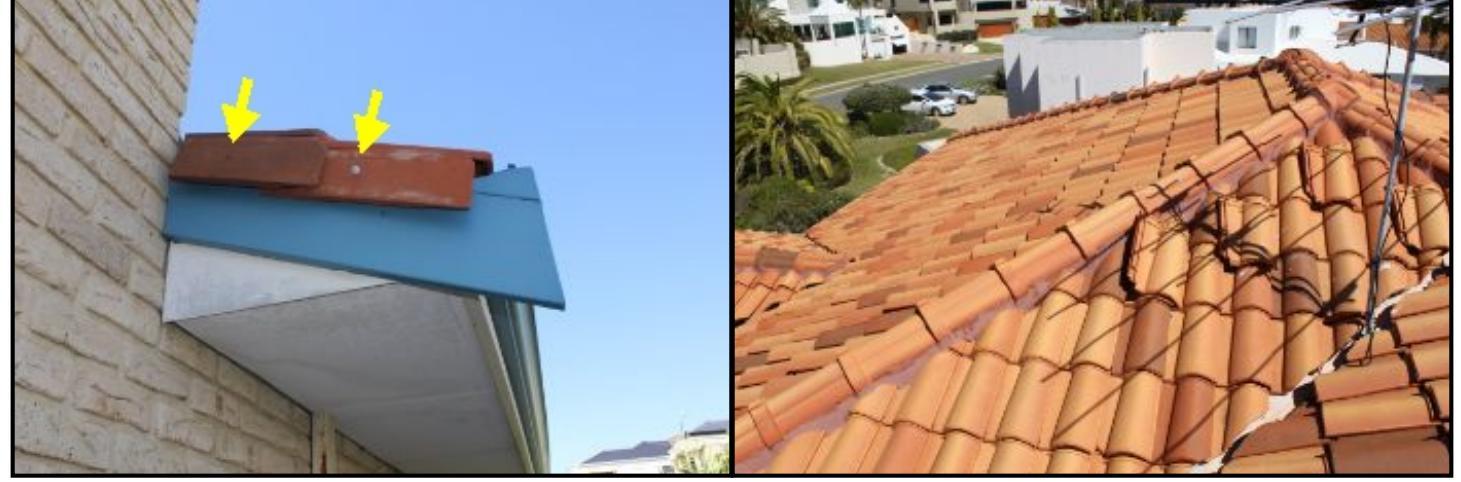
- Observations:
- No major system safety or function concerns noted at time of inspection.
- Barge tiles fixings have come loose and should be nailed back into position.

Loose and missing nails to barge tile

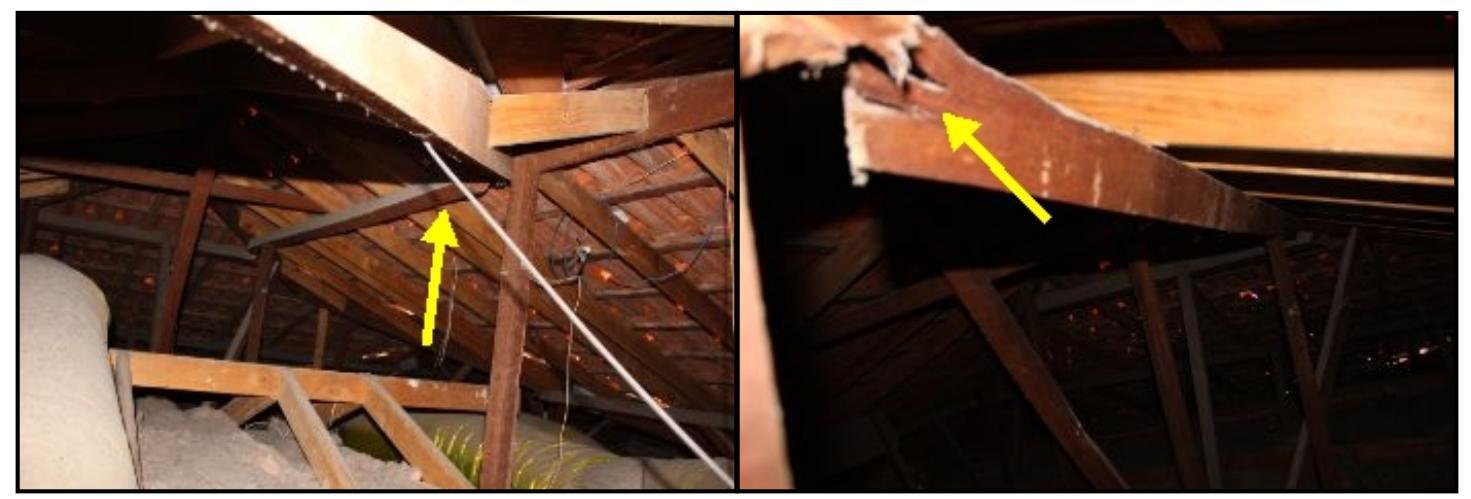
• There is an underpurlin which has a split end and so the fixings are no longer supporting the underpurlin. This underpurlin needs to have a strut support installed or the underpurlin needs to be fixed back to the hip rafter using a steel bracket or other fixing method.

Underpurlin is unsupported

No support to underpurlin

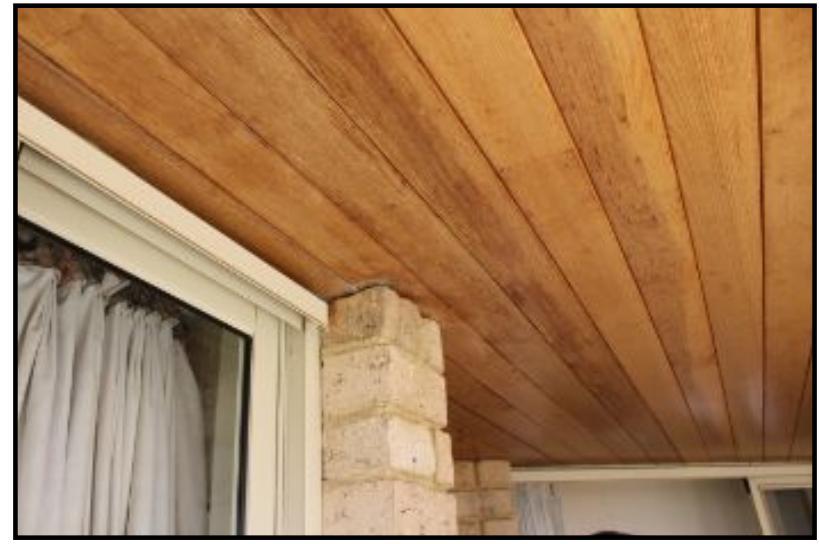
- The timber panelling to the deck ceiling if fading and needs to be re-sealed to extend the life of the panelling

Timber roof of deck needs re-sealing
